# Conservation Matters in Wales

## Challenging Buildings: the Search for Solutions

Post prints of a one-day conference held on Thursday 15 June 2006, at The Oakdale Institute, Museum of National History, St. Fagans, Cardiff.

# How to design a museum building that protects the collection without destroying itself

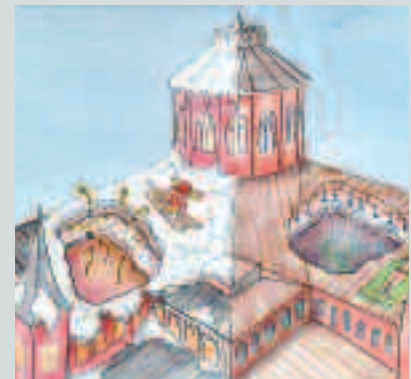
12

Figure 12: Here is a summary diagram of the winter charging of the roof followed by summer discharge of water into the interior of the building. The roof is now, after 30 years of this stressful cycle, in such poor condition that the building has been closed to the public.

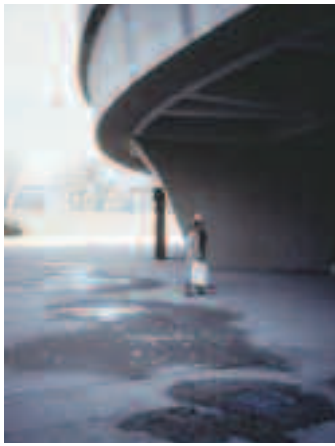
Figure 13: Office workers passing under the raised bulk of the Hirshhorn Museum in Washington DC are unaware of the danger from falling ice.

A similar process, but on a vertical plane, bombarded people passing under the Hirshhorn Art Gallery. The process is displayed in Figure 13 and explained in Figure 14. The warm air leaks out of this building not because of the stack effect but because the inside air is under pressure. This is to ensure that outside air does not enter by unauthorised routes to disturb the operation of the air conditioning.

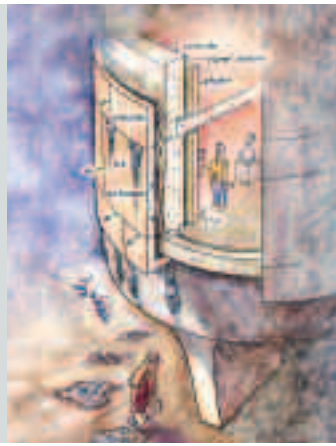
14

Figure 14: How the Hirshhorn makes ice. Warm, humidified air from the pressurised interior leaks out. Its water content freezes on the cold outer skin of the wall. The rising sun warms the concrete and melts the ice, which escapes through drain holes to the outside of the wall where it re-freezes because of evaporative cooling in the brisk wind of air of low relative humidity. Later, the growing solar radiation melts the ice where it touches the wall, sending slabs of ice to smash on the pavement below.

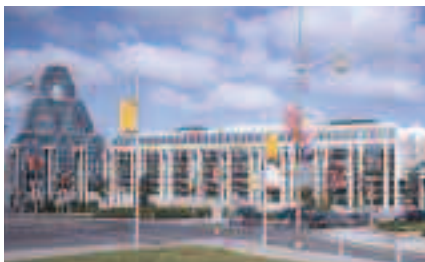
15

Figure 15: The National Gallery of Canada in Ottawa, opened in 1988. The architect is Moshe Safdie. Light is channelled through wells from the roof into the lower galleries. The elaborate sealing of the complicated skylights has not been entirely adequate to prevent condensation of water from escaping air.

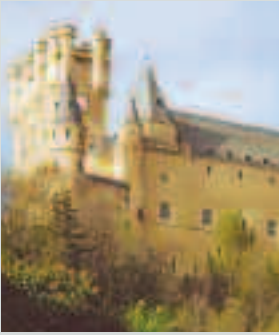
19

Figure 19: The castle of Segovia. Mainly 16th century with extensive rebuilding after a fire in 1862. The military archive lies behind the lowest row of windows.

To appreciate the potential of these building techniques one has, for most examples, to turn to more sober architecture, designed for purpose rather than for pomp. However, I start with a notably pompous building, the castle of Segovia in Spain (Figure 19). This comes from a vanished age when prestige was expressed through weighty construction, so the cellar of this

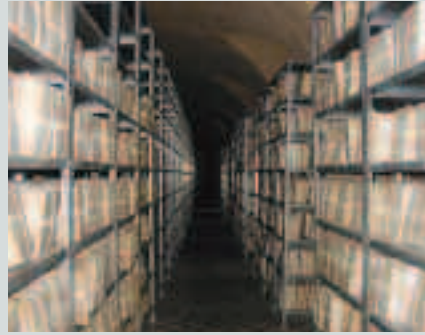
20

Figure 20: The military archive in the castle of Segovia. The room has massive temperature buffering from the approximately 13 metre thick limestone wall on the left. The room is lit by small windows in the thinner, but still massive wall on the right. (Photo by Victoria Smith).

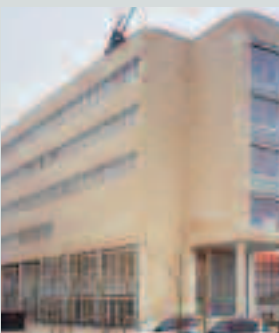
22

Figure 22: The Arne Magnaen archive of early Scandinavian manuscripts occupies the windowless volume behind the facade of this building in Copenhagen University. KHRAS Architects 2004.

An archive in Copenhagen (Figures 22-24) illustrates one strategy for reducing the RH without using air conditioning. In this archive heat is borrowed from the surrounding office areas and balanced against heat loss to the outside, so that the interior temperature lies about half way between inside and outside temperature.

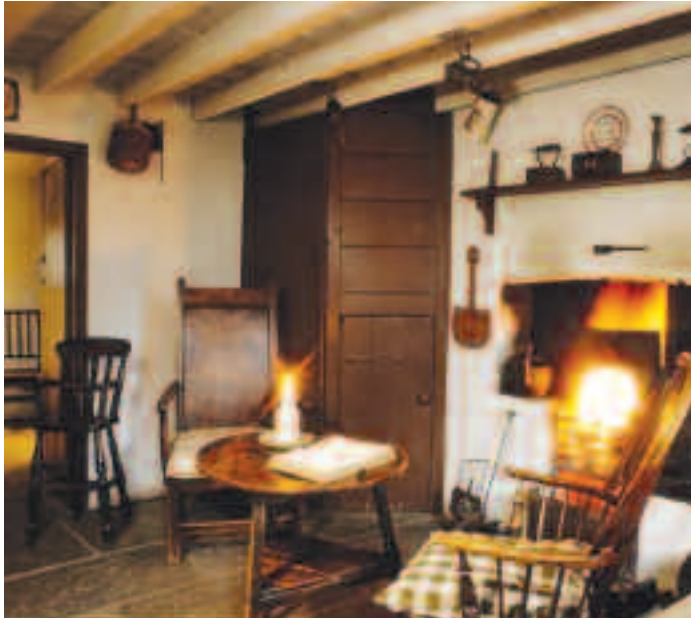
*A coal fire - the traditional method of heating a 19th century terraced house at Rhyd-y-Car, Merthyr Tydfil (now re-built at St Fagans)*

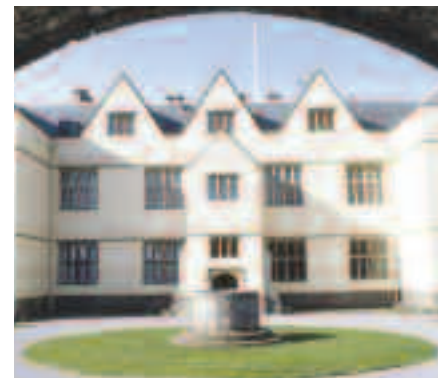
Exterior view of St Fagans Castle (built circa 1590). Electric under-floor heating was introduced into the kitchen in 1991.

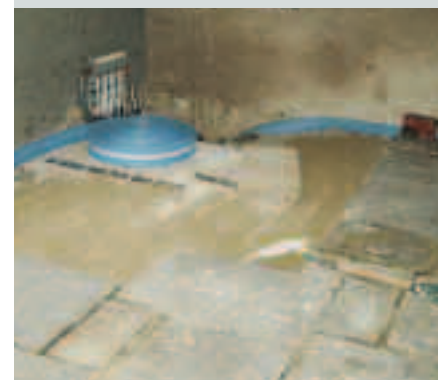
St Fagans Castle. Electric under-floor heating was introduced into the kitchen, the flagstone floor acting as a heat reservoir.

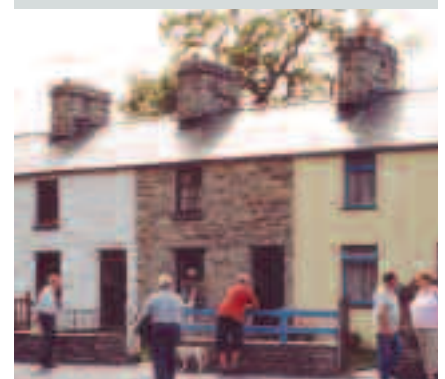
Fron Haul: a terrace of four houses moved from Tanygrisiau, Gwynedd, and re-erected at the National Slate Museum, Llanberis in 1998. Electric under-floor heating was incorporated in the houses, the slate-flag floors acting as heat reservoirs, enabling a constant background temperature to be maintained even at nights and in winter.

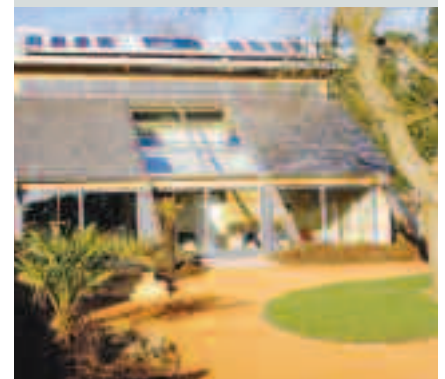
Y Tŷ Gwyrdd (a 'House for the Future') designed by Jesticoe & Whiles and built at the Museum in 2001. A ground source heat pump is one of four different systems available for heating the interior.

The building can be heated in several ways. Large areas of glazing on the south side mean that the interior can quickly be warmed by direct sunlight. A ground source heat pump linked to a 35m deep borehole circulates heated water via a compressor unit. A constant temperature of 10°C underground is raised three-fold in the heat pump and this is then fed under the floor, which acts as a giant heat reservoir.

There is also a small stove in the main living space downstairs which burns pellets made from recycled sawdust. However, the building is so efficient that the stove has only been used on very rare occasions.

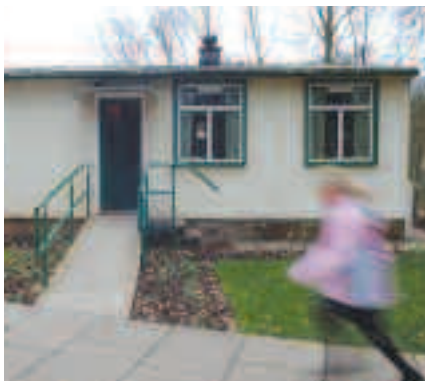
Aluminium prefab: moved to the Museum in 1998. An electric under-floor heating system was installed in order to maintain even temperatures throughout the building.

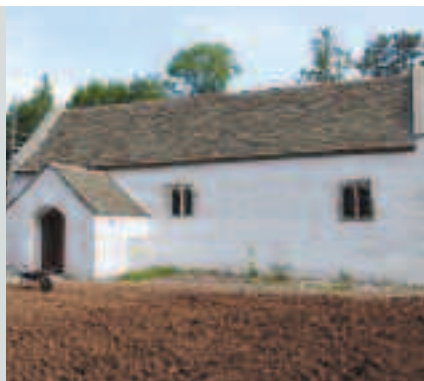
St Teilo's church: rebuilt at the Museum to its appearance circa 1520. A ground source heat pump has been incorporated to improve inside temperatures and humidity levels.

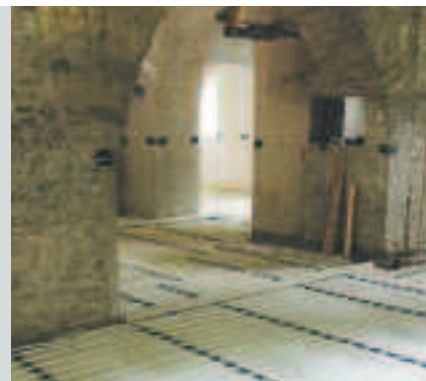
St Teilo's church: Under-floor pipework being laid inside the church on top of a limecrete base. The flagstone floor acts as a heat reservoir and the system is controlled by hydrostrats located in the roof-space.
